Manhole Inspection Summary

Manhole # S35W__001MH

Insp Date: **3/3/08 8:13 AM**

Location Address: **1800 s charles**

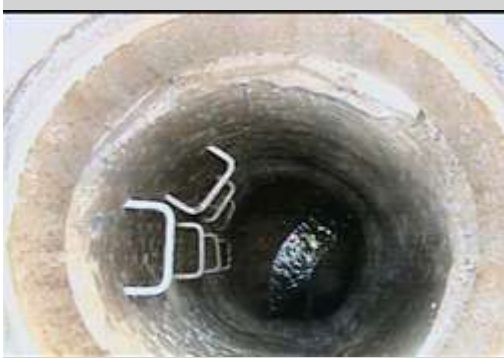
Defect 1

Steps Count: **7** Missing: **0** ☒ **Corroded**

steps

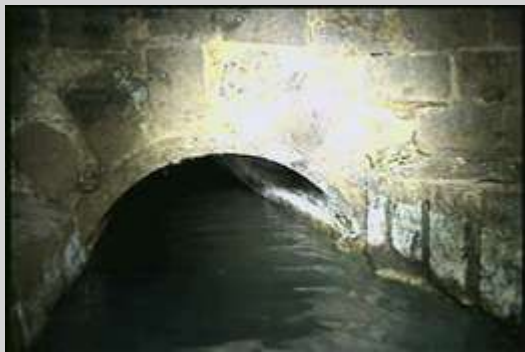
12 O'Clock Outflow

12 in. Circular Gravity Sewer
Pipe Out @ 12 O'Clock

Pipe Material: **Clay** ☐ Pipe Lined

Invert Depth: **12.60** (ft.) Flow Characteristics: **Fast**

Deposits: ☒ None ☐ Mud ☐ Sludge ☐ Debris ☐ Grease

Infiltration: **None** Pipe Seal Cond: **Unknown**

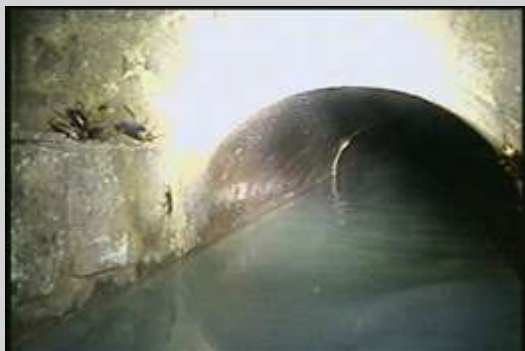
6 O'Clock Inflow

12 in. Circular Gravity Sewer
Pipe In @ 6 O'Clock

Pipe Material: **Clay** ☐ Pipe Lined

Invert Depth: **12.40** (ft.) Flow Characteristics: **Fast**

Deposits: ☒ None ☐ Mud ☐ Sludge ☐ Debris ☐ Grease

Infiltration: **None** Pipe Seal Cond: **Unknown**
